Intel® Xeon™ MP Processor

Specification Update

June 2003

Document Number: 290741-015

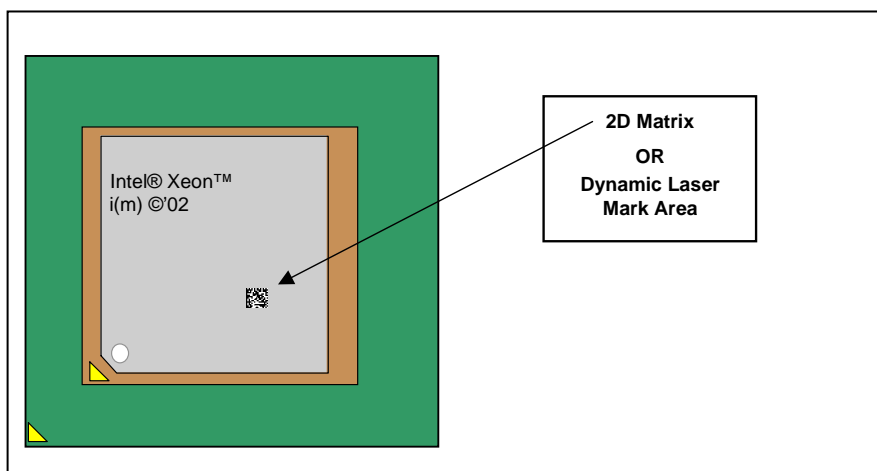
Figure 1. Top Side Processor Marking – Production Part

INTEL® XEON™ PROCESSOR MP and INTEL® XEON™ PROCESSOR MP WITH UP TO 2-MB L3 CACHE ON 0.13- MICRON PROCESS MARKINGS (603-pin INT-mPGA)
